Bad Injectors & Multiplexers Sent from CERN

Xinfei Huang

Brandeis University

21 May 2021

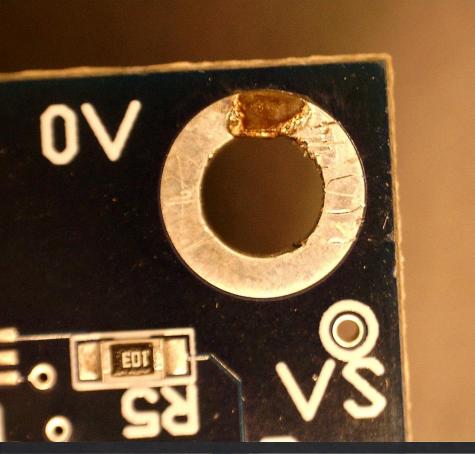
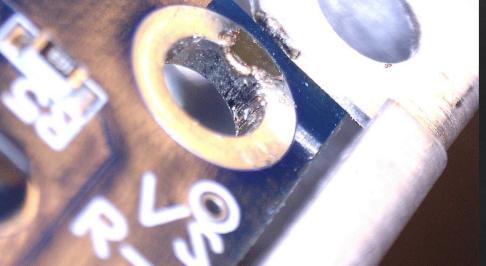
M48

- Symptoms
 - 1. No image with BCAM
 - 2. No loop back with device
 - 3. Burn marks (see fig.)
 - 4. Gap between the burn marks is in the interval (0.81,0.98) mm
 - 5. Hot logic chip (U65)
 - 6. Abnormally high supply current (next slide)

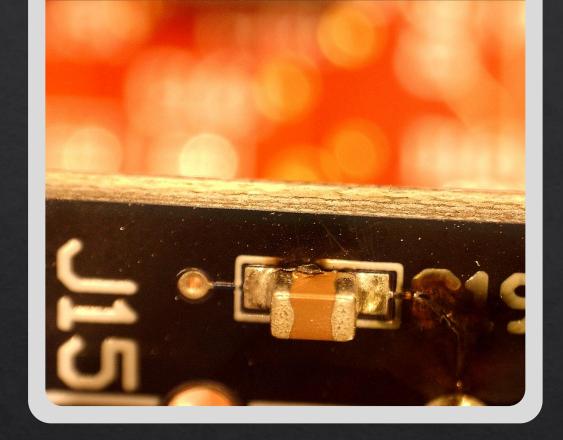
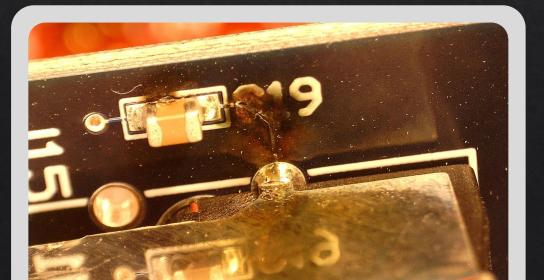
M116

- 1. No image with BCAM
- 2. ∼50ns loop back without device
- 3. Burnt PCD and capacitor (see fig.)
- 4. Abnormally high supply current (next slide)

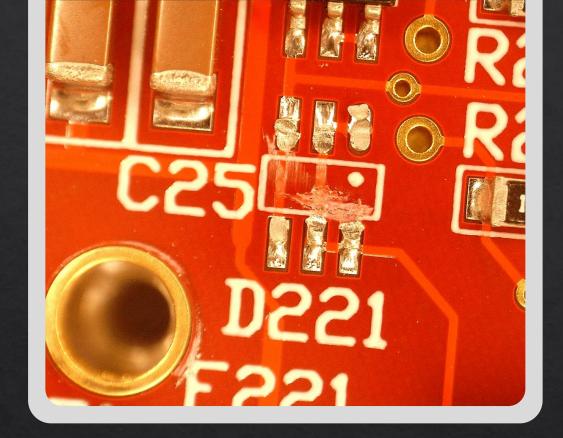
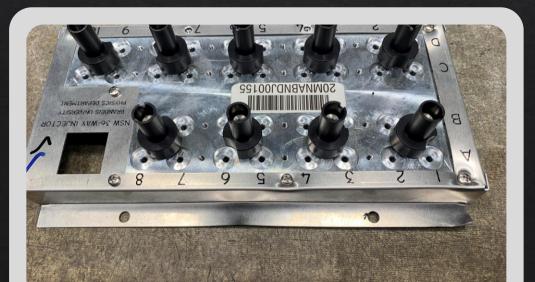
J155

- 1. No LED works with HEX command
- 2. Casing deformed (see lower fig.)
- 3. C25 gone with possibly damaged track (see upper fig.)

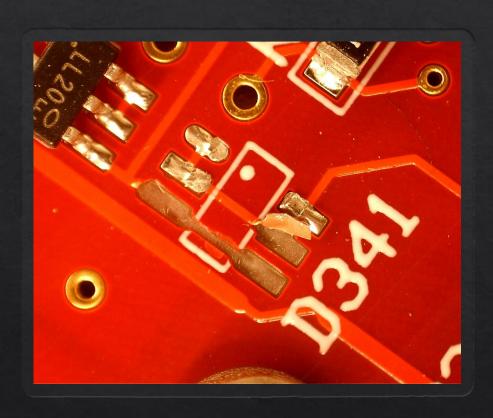
J113

- 1. D341 gone
- 2. Pin pads & track of D341 damaged (see fig.)
- 3. U3 gone

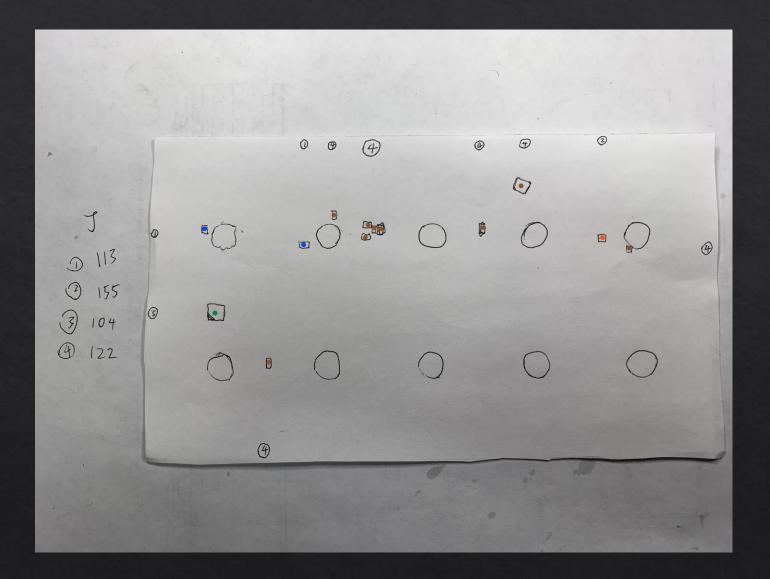
- In transportation or storage, injectors are <u>stacked in a way</u> that the knobs of one injector point at the exposed back side of another, presumably with bubble wrap or equivalent as separator.
- Fig.: Sketch of the positions of the knobs and damages on several injectors.
